**MOSER**  
ROOFING SOLUTIONS  
- COMMERCIAL ROOFING PROFESSIONALS -

# Inspection Report

**Prepared For:**  
SAMPLE EPDM

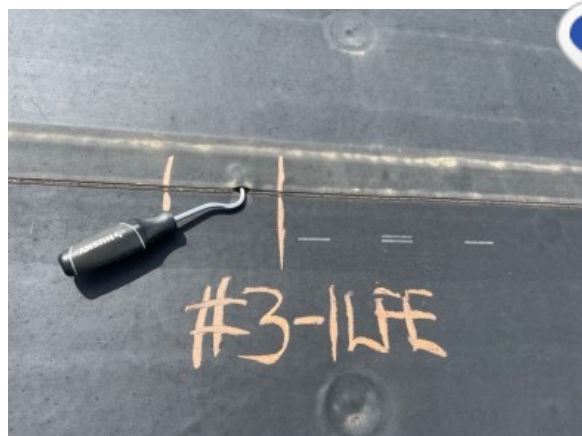
**Open Seams - 6" Flashing (Emergency)**

Quantity: 1 LF

1 LF of seams have failed and are open.

Clean and prime the area to ensure proper adhesion of new flashings. Apply 6" flashings to the area and apply lap seal to the entire patch.

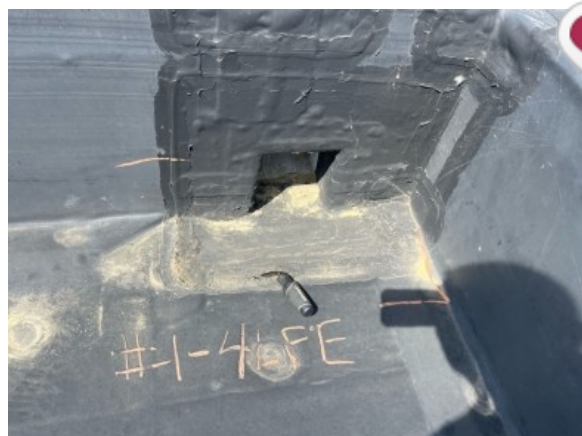
**Open Seams - 9" Flashing (Emergency)**

Quantity: 4 LF

4 LF of seams have failed and are open.

Clean and prime the area to ensure proper adhesion of new flashings. Apply 9" flashings to the area and apply lap seal to the entire patch.

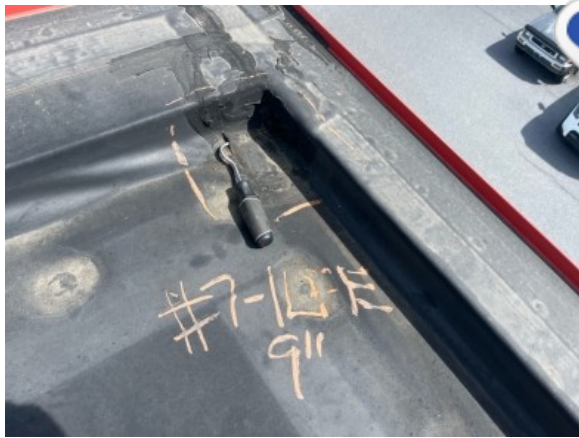
**Open Seams - 9" Flashing (Emergency)**

Quantity: 1 LF

1 LF of seams have failed and are open.

Clean and prime the area to ensure proper adhesion of new flashings. Apply 9" flashings to the area and apply lap seal to the entire patch.

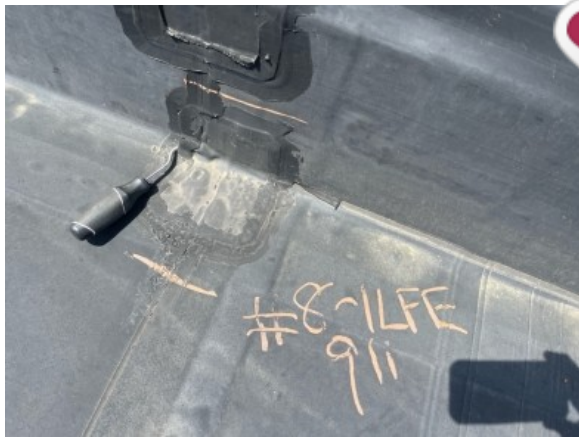
**Open Seams - 9" Flashing (Emergency)**

Quantity: 8 LF

8 LF of seams have failed and are open.

Clean and prime the area to ensure proper adhesion of new flashings. Apply 9" flashings to the area and apply lap seal to the entire patch.

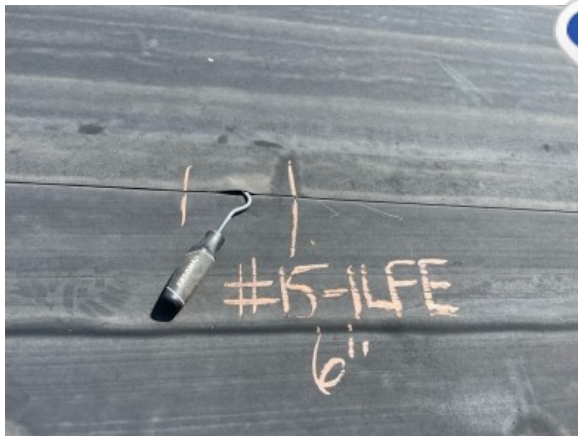
**Open Seams - 6" Flashing (Emergency)**

Quantity: 1 LF

1 LF of seams have failed and are open.

Clean and prime the area to ensure proper adhesion of new flashings. Apply 6" flashings to the area and apply lap seal to the entire patch.

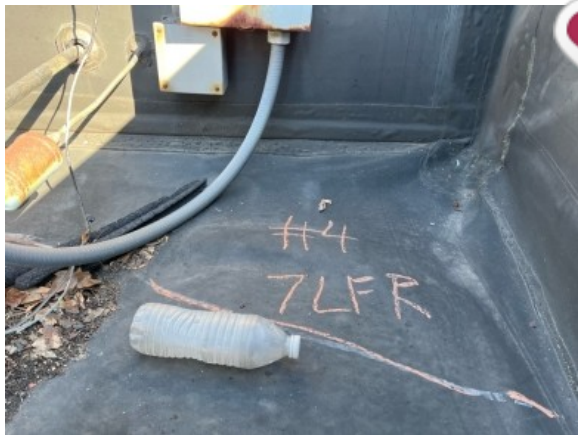
**Delaminated Membrane**

Quantity: 7 LF

The membrane has delaminated from the insulation it was originally adhered to and is at risk for complete failure and blowing off.

Install batten bar mechanically fastened over area of membrane that has delaminated and seal with flashing.

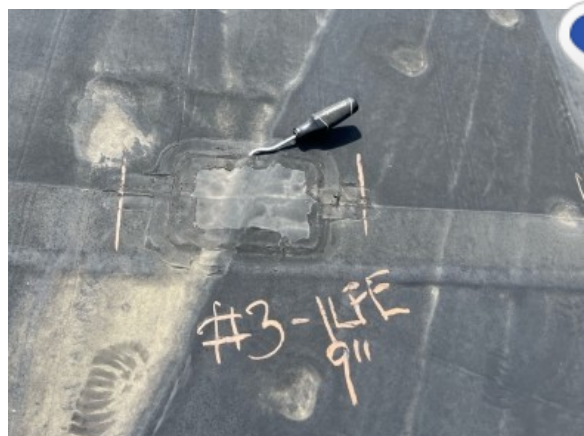
**Open Seams - 9" Flashing (Emergency)**

Quantity: 1 LF

1 LF of seams have failed and are open.

Clean and prime the area to ensure proper adhesion of new flashings. Apply 9" flashings to the area and apply lap seal to the entire patch.

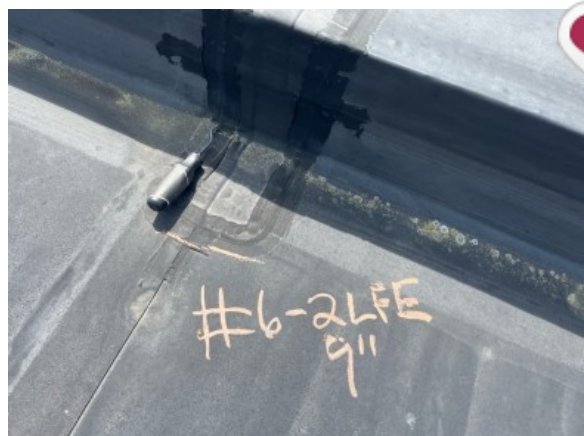
**Open Seams - 9" Flashing (Emergency)**

Quantity: 2 LF

2 LF of seams have failed and are open.

Clean and prime the area to ensure proper adhesion of new flashings. Apply 9" flashings to the area and apply lap seal to the entire patch.
