**MOSER**  
ROOFING SOLUTIONS  
- COMMERCIAL ROOFING PROFESSIONALS -

# Inspection Report

**Prepared For:**  
SAMPLE EPDM

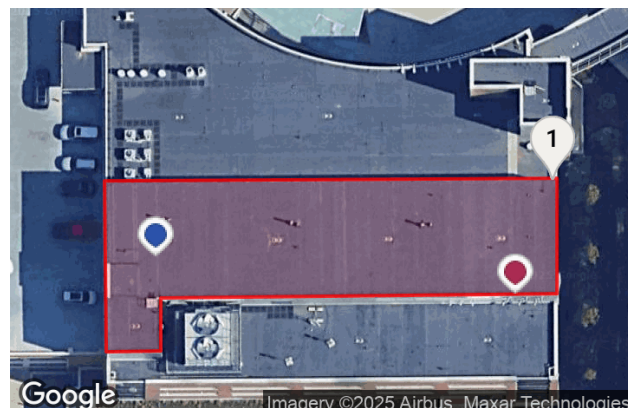
**Open Seams - 6" Flashing (Emergency)**

Quantity: 1 LF

1 LF of seams have failed and are open.

Clean and prime the area to ensure proper adhesion of new flashings. Apply 6" flashings to the area and apply lap seal to the entire patch.

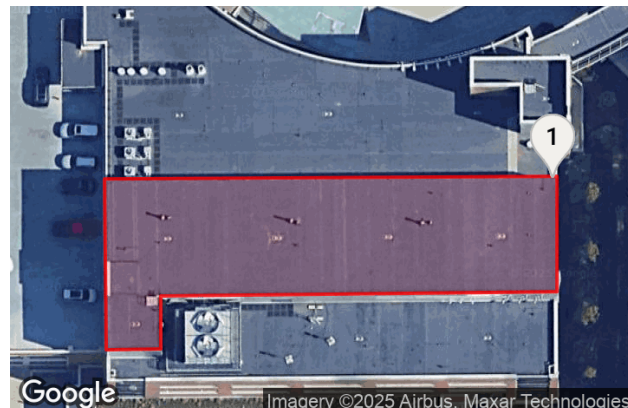
Membrane:	B
Flashings:	C
Sheet Metal:	A-
<hr/>	
Overall:	B

Roof is in "Good" condition but may have need for minor preventative maintenance. We recommend making all emergency repairs immediately and budgeting for remedial repairs. The deficiencies listed in this report were those present and observed during our inspection, but it is not a guarantee that there are no other deficiencies in the roof system that were either not present or observed at the time of our inspection. Additional leaks beyond the original repair scope to be repaired at time and material rates.

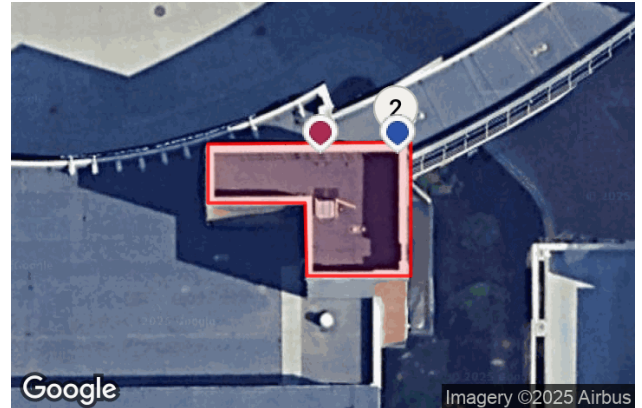
**Open Seams - 9" Flashing (Emergency)**

Quantity: 1 LF

1 LF of seams have failed and are open.

Clean and prime the area to ensure proper adhesion of new flashings. Apply 9" flashings to the area and apply lap seal to the entire patch.

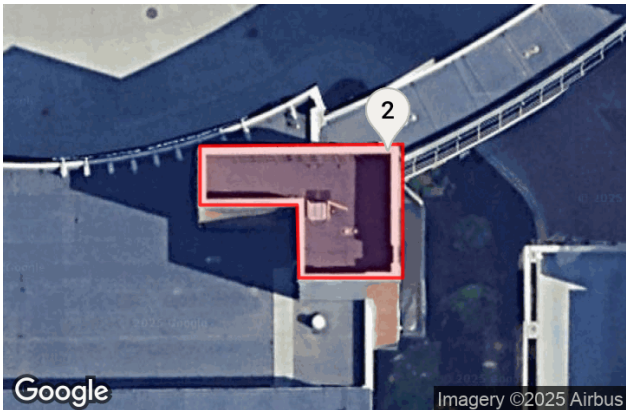
Membrane:	C
Flashings:	C-
Sheet Metal:	A-
<hr/>	
Overall:	B-

Roof is in "Good" condition but may have need for minor preventative maintenance. We recommend making all emergency repairs immediately and budgeting for remedial repairs. The deficiencies listed in this report were those present and observed during our inspection, but it is not a guarantee that there are no other deficiencies in the roof system that were either not present or observed at the time of our inspection. Additional leaks beyond the original repair scope to be repaired at time and material rates.

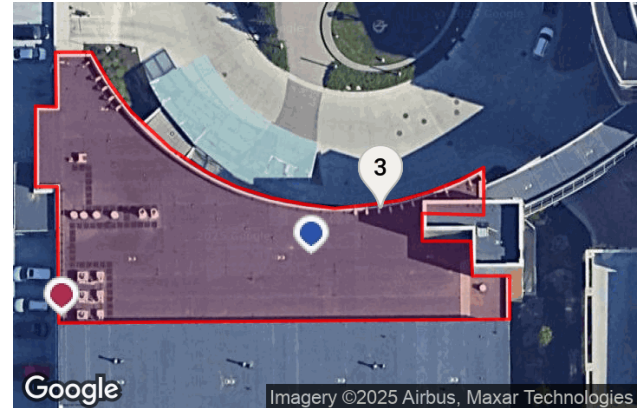
**Open Seams - 6" Flashing (Emergency)**

Quantity: 1 LF

1 LF of seams have failed and are open.

Clean and prime the area to ensure proper adhesion of new flashings. Apply 6" flashings to the area and apply lap seal to the entire patch.

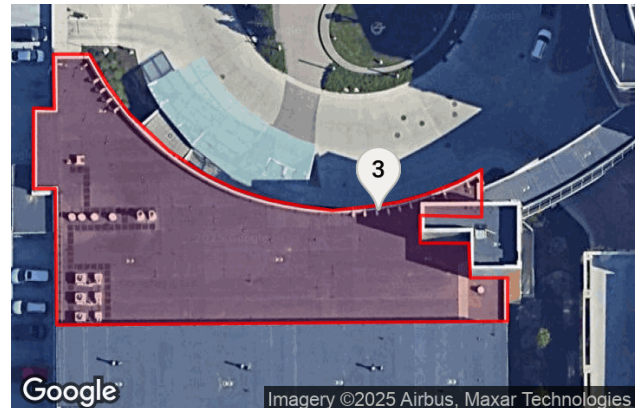
Membrane:	D
Flashings:	D-
Sheet Metal:	C-
<hr/>	
Overall:	D

Roof condition is "Poor". The roof is either at or nearing the end of its service life or is a roof with significant deficiencies present. Carefully selected preventative maintenance may help cost effectively extend the life of this roof and reduce unnecessary leaking, or it may not. We recommend making all emergency repairs immediately and budgeting for remedial repairs. The deficiencies listed in this report were those present and observed during our inspection, but it is not a guarantee that there are no other deficiencies in the roof system that were either not present or observed at the time of our inspection. Additional leaks beyond the original repair scope to be repaired at time and material rates.

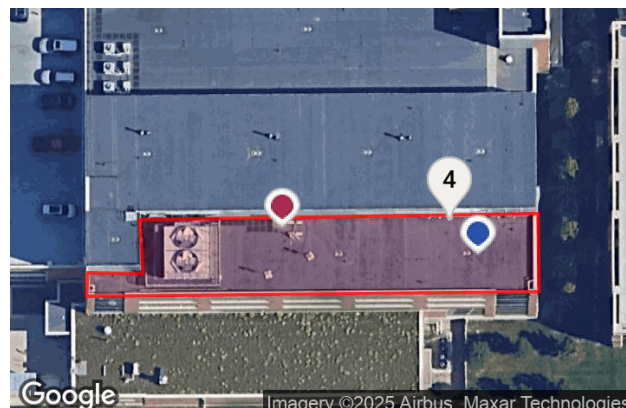
**Open Seams - 9" Flashing (Emergency)**

1 LF of seams have failed and are open.

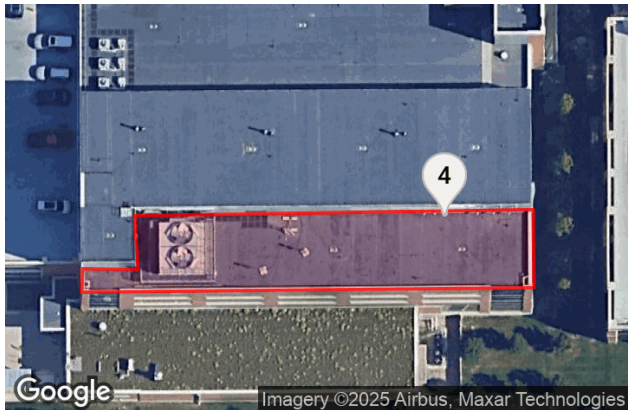
Membrane:	C
Flashings:	D
Sheet Metal:	B-
<hr/>	
Overall:	C

Roof condition is "Fair". The roof is either older with age-related conditions developing or it is a younger roof that is not performing as well as would be expected for its age. We recommend making all emergency repairs immediately and budgeting for remedial repairs.
